**Missouri River Flood 2011  
Vulnerabilities Assessment Report  
Volume II-Technical Report**

**Northwestern Division  
US Army Corps of Engineers**

**October 2012**

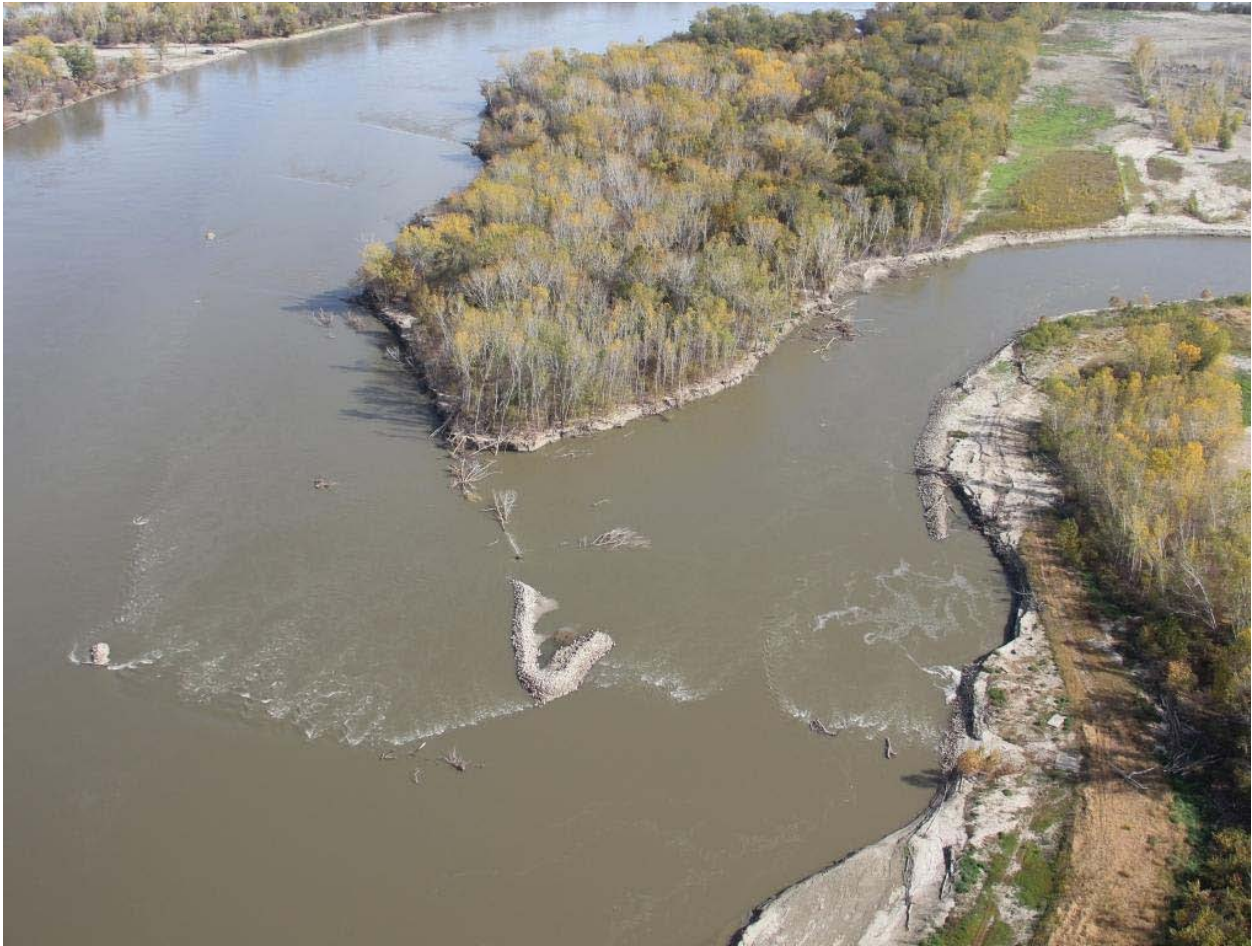
**Figure 27. Upper Kansas Bend SWH Chute Inlet at River Mile 546 (facing downstream) - 2011 Post Flood. Flood Erosion Flanked the Stone Protection at the "V" Structure Along the Downstream Bankline**

NWO and NWK have constructed a number of SWH projects under the MRRP authority. Each district performed early reconnaissance efforts to quickly provide an overview of current conditions. On-going and future study efforts will be used to provide additional information and recommendations. The following figures show some of the typical SWH chute control structure damage. Figure 25 shows a 2005 pre-flood image of Upper Kansas Bend SWH chute inlet and Figure 26 shows the chute inlet with flood damage. SWH assessments discussions that follow will be by district.

Chutes at Council Bend and Upper Hamburg Bend have eroded scour holes approaching the levee toe. See Figure 27 for levee toe scour repair activities at Upper Hamburg Bend.

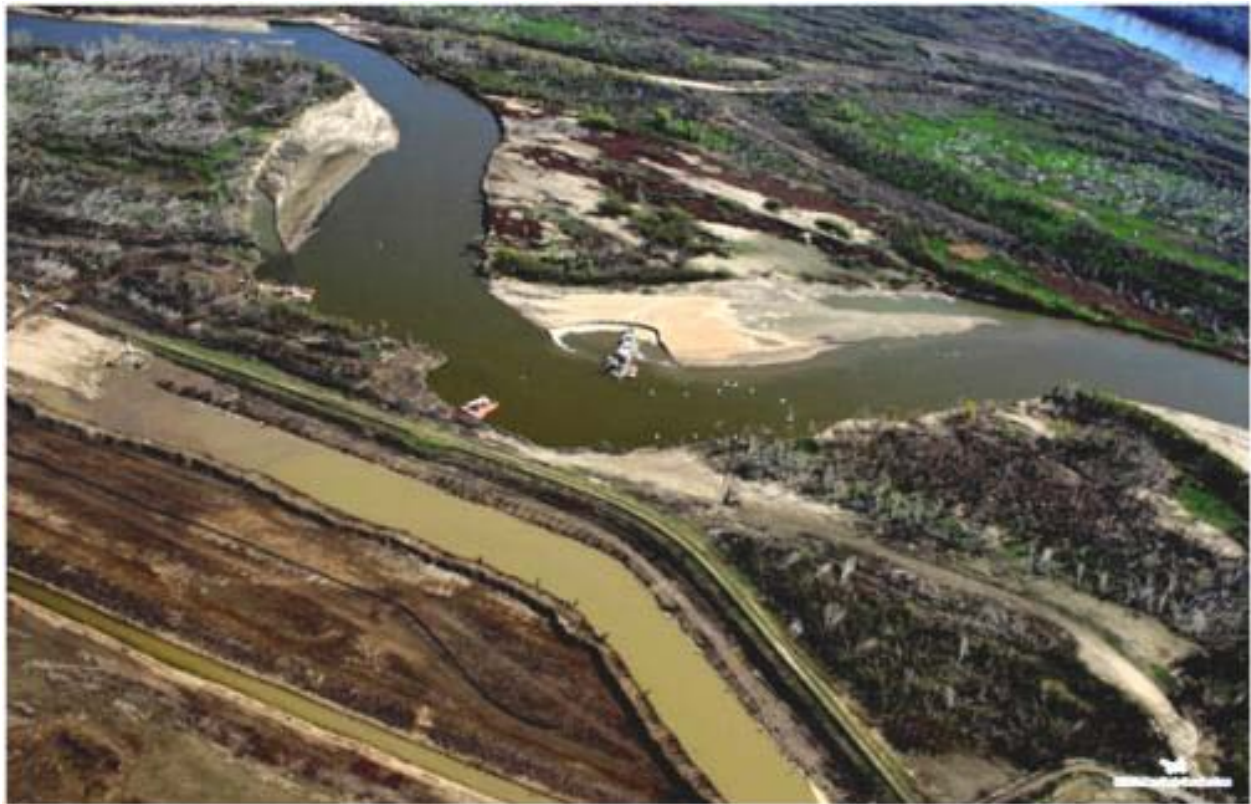
**Figure 28. Upper Hamburg Bend Levee Toe Scour Repair Area**

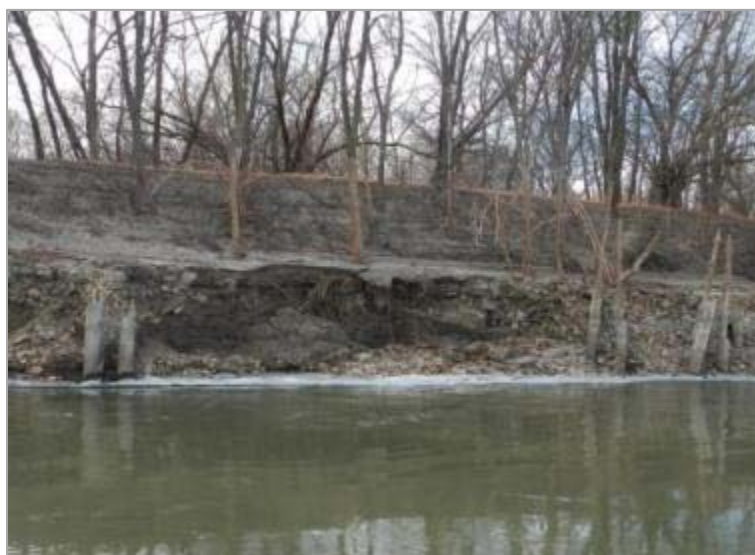
**Figure 29. Revetment Near River Mile 693.5**

Repair Dimensions: Approximately 410 ft long and 6 ft high.

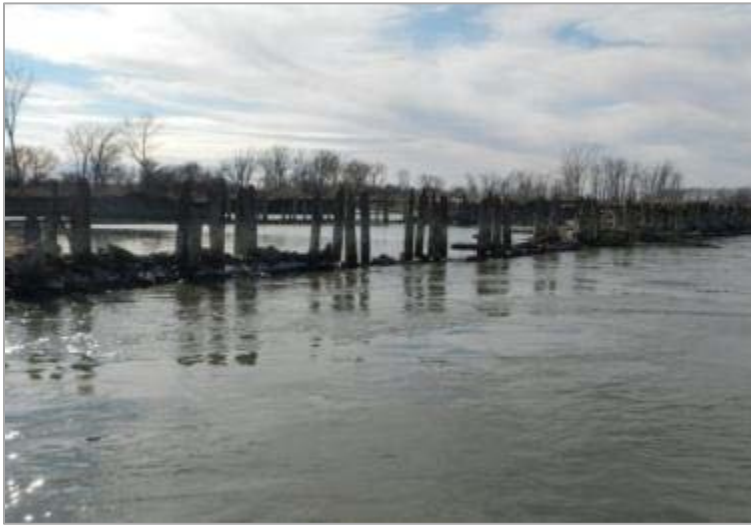
**Figure 30. Revetment Near River Mile 679.8**

Repair Dimensions: Approximately 100 ft long and 7 ft high.

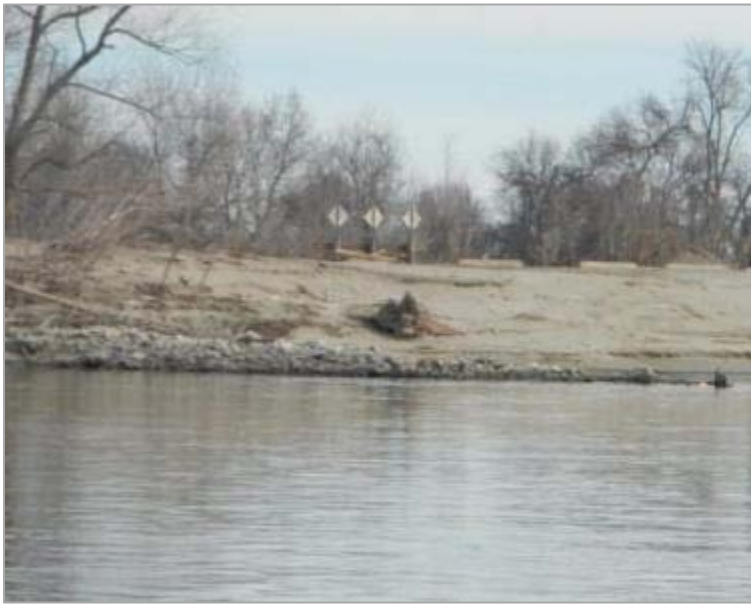
**RM 640.19**

**Figure 31. Dike Near River Mile 640.2**

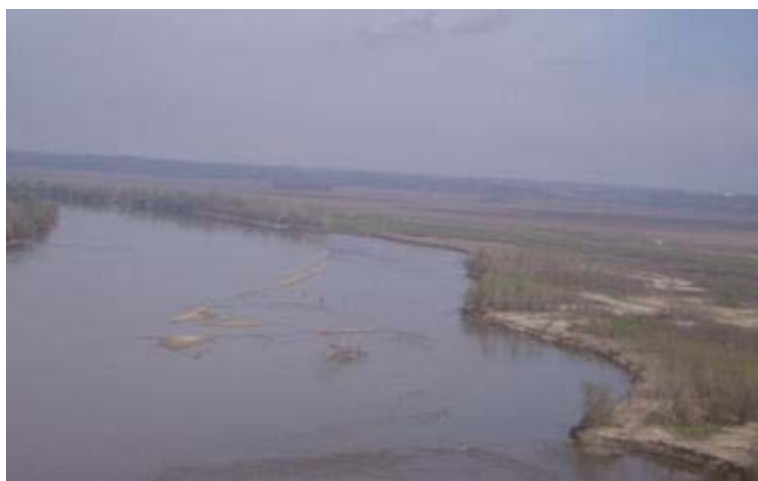
**Figure 32. Wolf Creek Bend Revetment Chute Erosion**

Damage: Chute Erosion

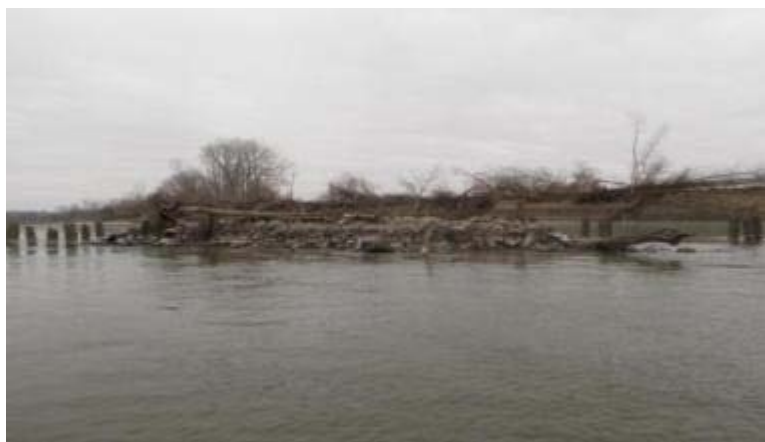
**Figure 33. Flanked Dike at River Mile 322.4 on Right Bank.**

Damage: Flanked Dike

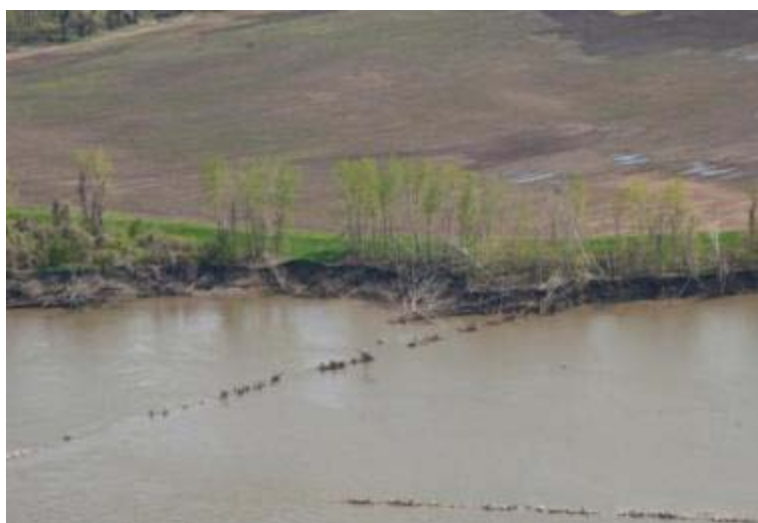
**Figure 34. Dike and Revetment Damage at River Mile 250.5**

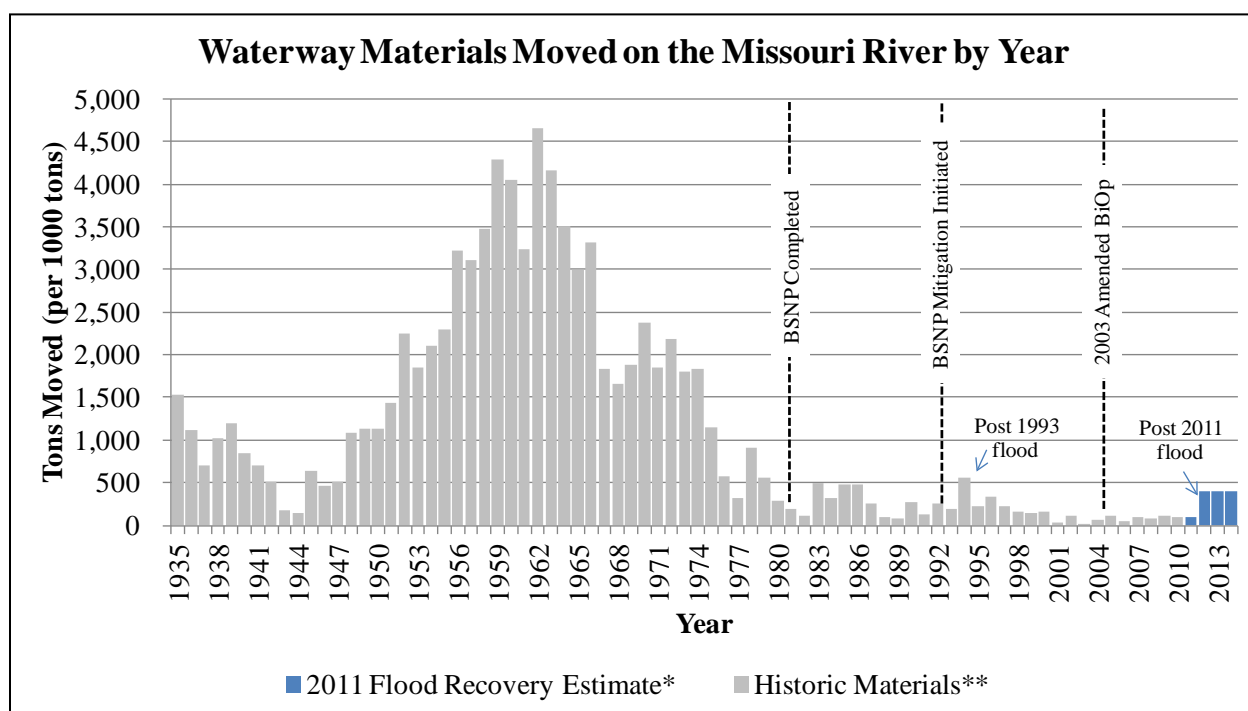
**Figure 35. Waterway Materials Moved on the Missouri River by Year**

As stated in the District Assessment Findings, the estimated stone tonnage of waterway materials for structure damage repairs for NWO is 509,000 tons and NWK is 680,000 tons. The total is 1,189,000 tons. Figure 34 shows this tonnage transported on the river and placed equally over the years 2012-2014 in comparison to the historic waterway materials tonnage transported on the Missouri River since 1935. The comparison helps to understand the damage repair stone placement effort to the historic work during BSNP construction and O&M prior to 1980 and project O&M after the BSNP was completed in 1980.

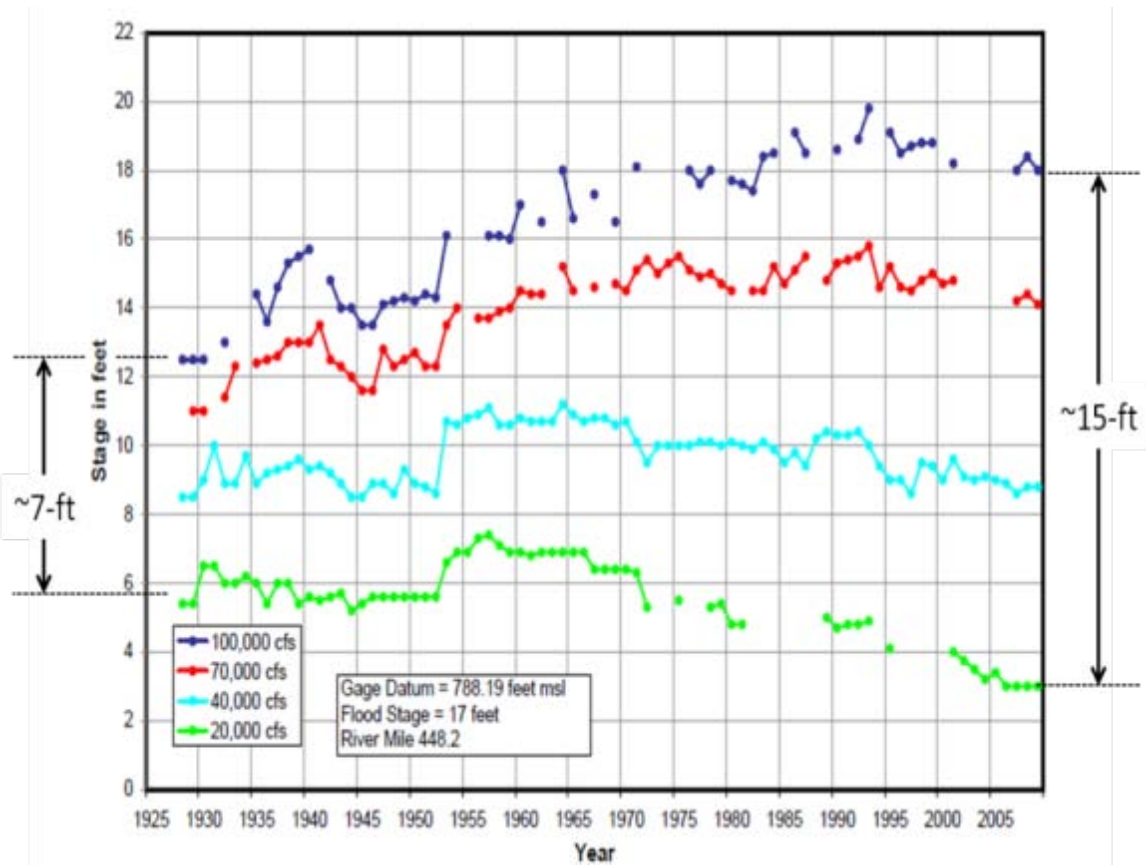
**Figure 37. Stage Trends on the Missouri River at St. Joseph, Missouri**

Results varied depending on flow magnitude, type and amount of action, etc, but in general, river widening and levee setbacks showed promise to reduce flood levels, and as a result, potential to reduce the frequency of levee overtopping (see Figures 36 and 37). However, while some flood storage was observed, ability to reduce river levels downstream of the projects due to the added flood storage appeared to be minor for simulation of the 2007 flood and existing completed habitat projects. With the concept tested, and in light of approximately 16 levee overtops and or breaches in 2011, several questions remain:

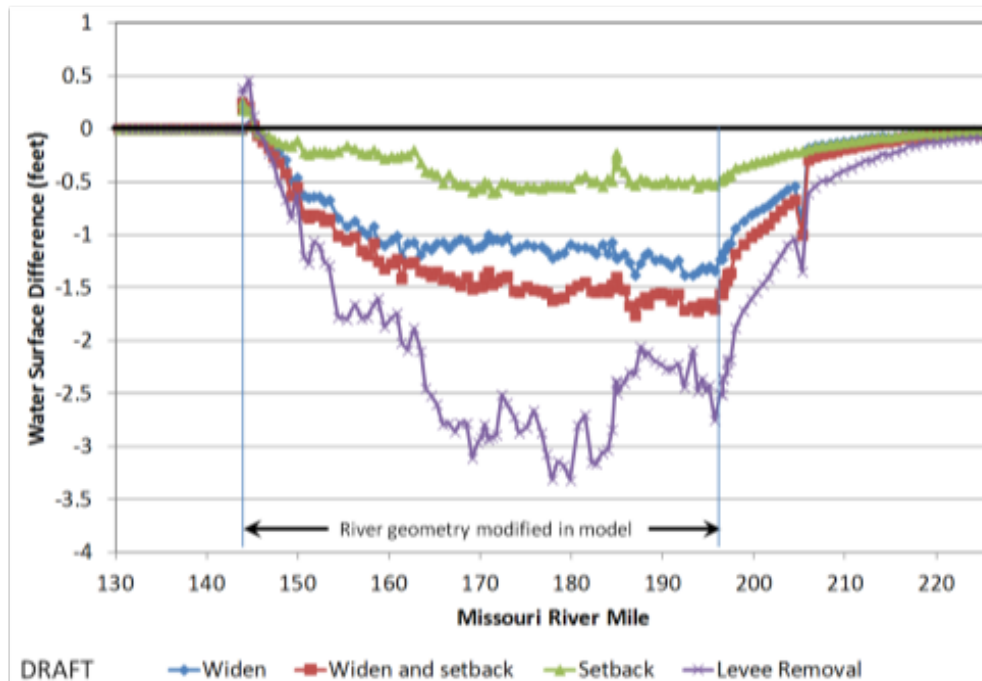
**Figure 38. Comparison of 10-Yr Flood Heights for Various Hypothetical River Geometries**

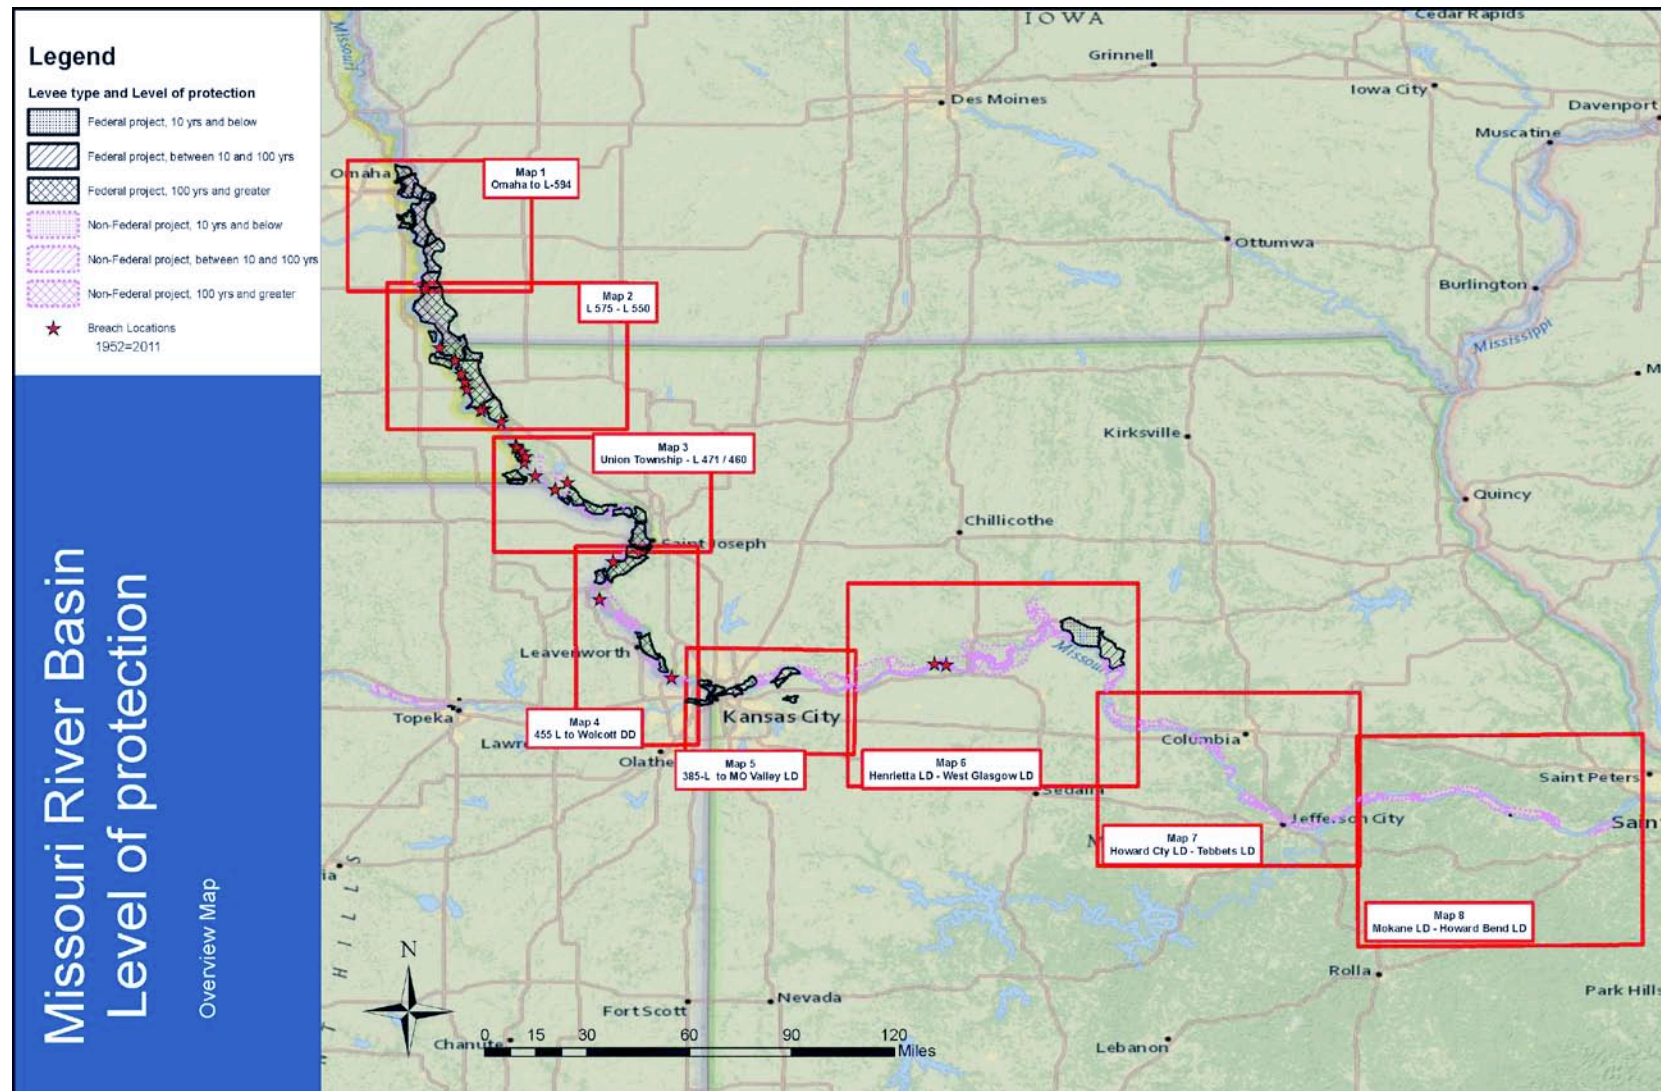
Figure 39. Missouri River Basin Levee Vulnerability

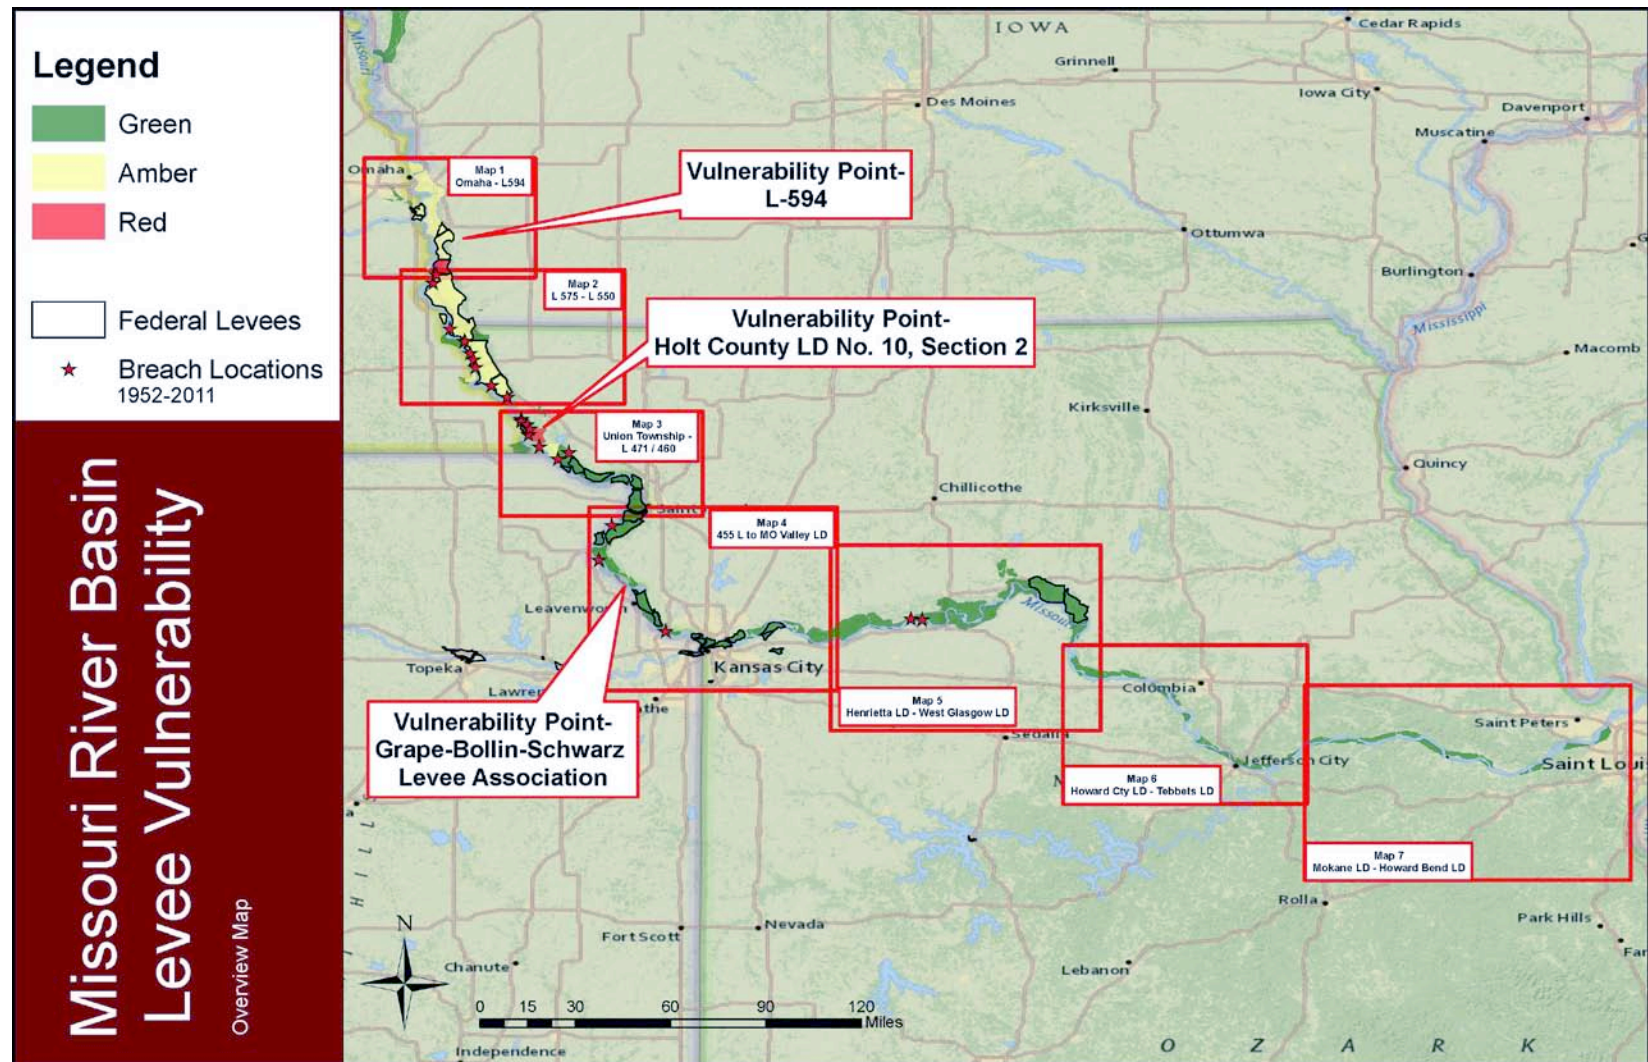
The levees in Figure 40 provide risk management downstream of the last mainstem dam (Gavins Point). The extensive area impacted by the flood event contained numerous federal and nonfederal levees, with 75 levees damaged - stretching 500 miles on the Missouri River from Mile 623 to Mile 120.

Figure 48. NWD Missouri River Levees Impacted in 2011 Flood

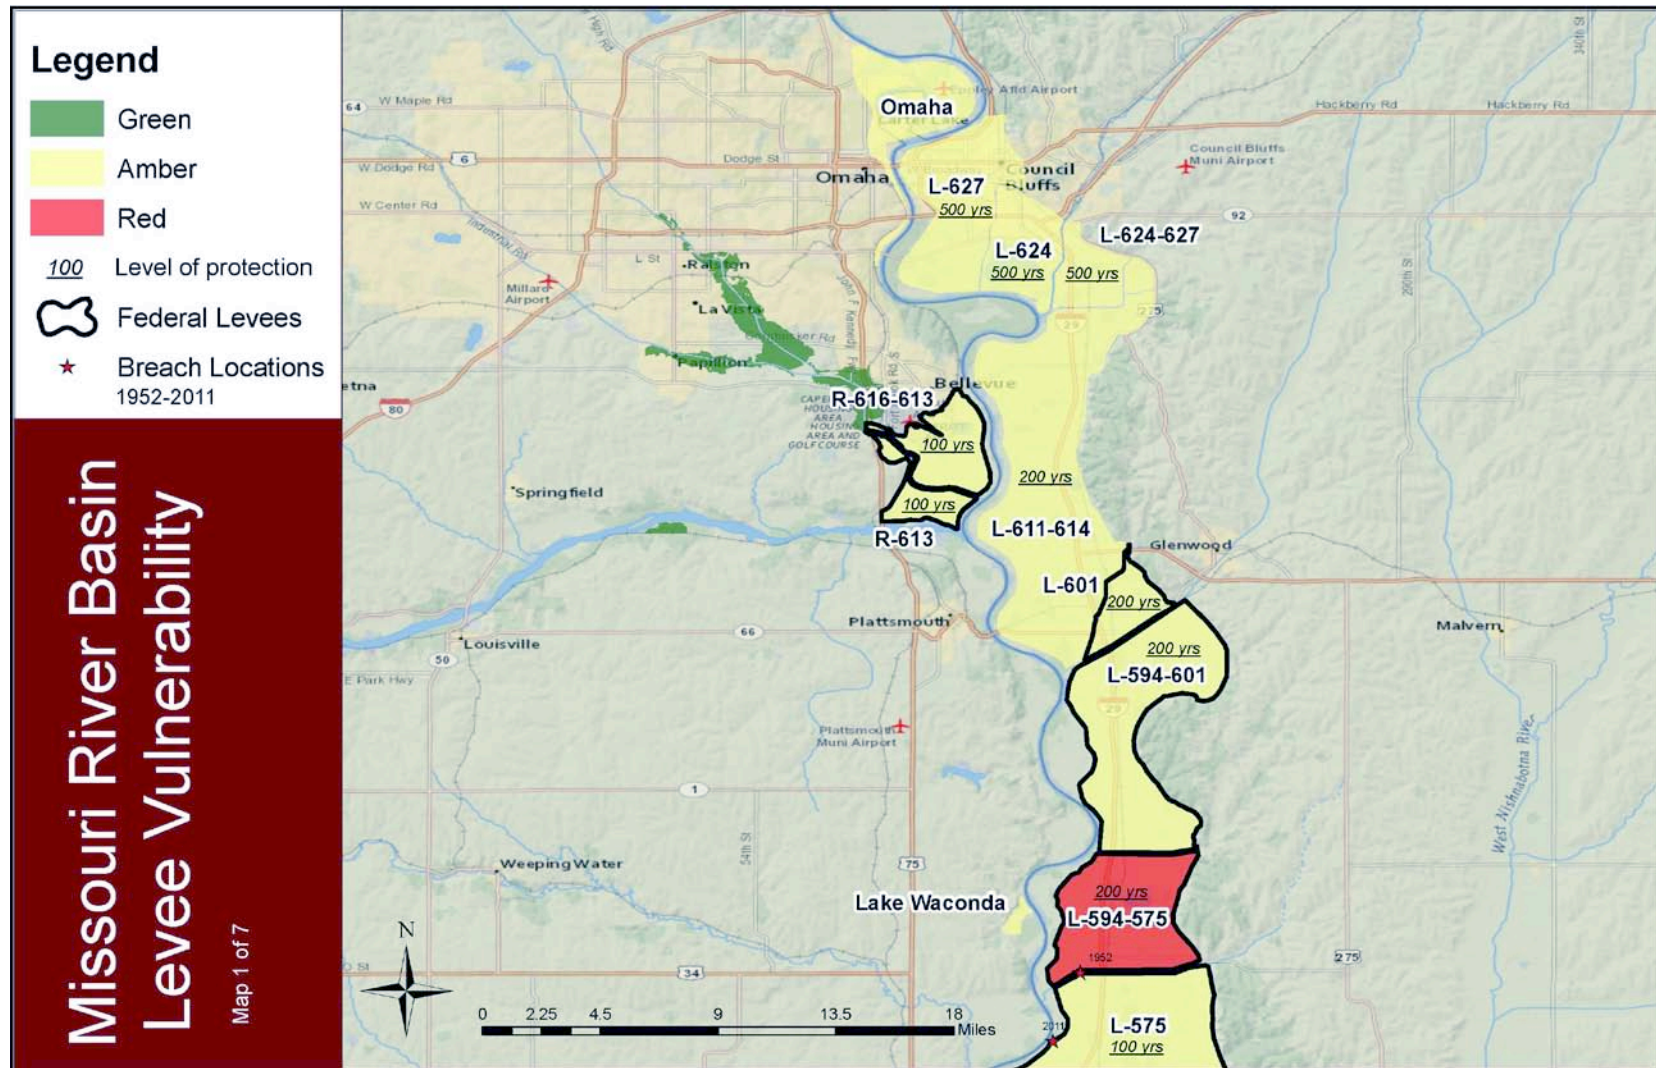
Figure 49. Omaha - L-594

Green, amber, and red designations represent the flood vulnerability of the areas protected by the levees as of the printing of this report.

- Green - Levee will be substantially whole on that date for flood season. No breaches or significant scour concerns, riverside or landside. No significant seepage concerns. Levee is fully capable of meeting its designed purposes.
- Amber - Levee is substantially whole with a critical section that has been returned to design height; levee is flood fightable; or the temporary measure from last year is still in place. No breaches; major scouring addressed; (This will be a subjective call made by the district, so all aspects of what the district deems as being critical repair may not be listed here.)
- Red - Levee has breaches or major scouring such that the levee will not provide flood protection; it is not flood fightable.

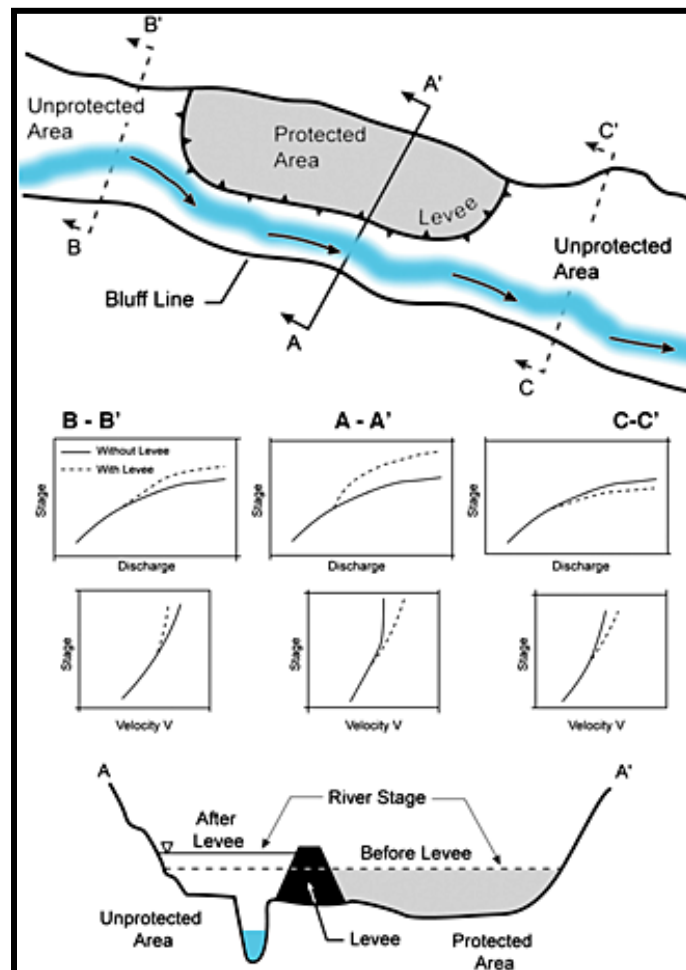
By locating levees too near the river, hydrologic conditions are adversely impacted. The construction of a levee removes flow area available for the passage of flood waters. The areas located closest to the river generally provide the deepest flow areas and as such the most conveyance. In response, velocities increase and water surface elevations increase to obtain more flow area. Figure 56, taken from Heini and Pinter 2012, shows the typical response of hydrologic conditions resulting from the construction of a levee. For cross sections upstream or adjacent to a levee, this figure shows increased stages resulting from levee construction during high flow events.

**Figure 56. Impacts of Levees on Hydraulic Relationships (Taken from Heine, Pinter, 2012)**

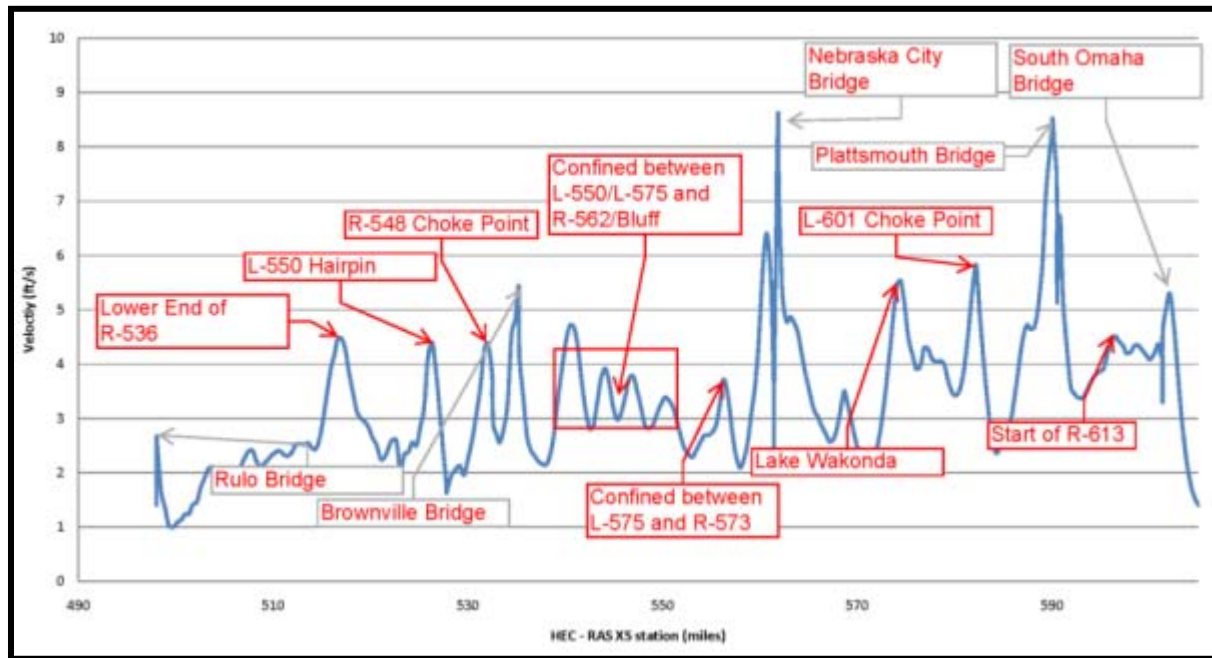
A plot of velocities along the Missouri River can be used to identify a number of locations with constrictions, or “pinch points”. Figure 57 shows the velocities modeled in the 100-year flood event from Rulo to Bellevue, Nebraska. This figure identifies the relationship between manmade constrictions such as bridges and levees and high velocity locations.

**Figure 57. Velocity Profile of the Missouri River**

Induced stages, or increased water surface elevations are the result of decreased conveyance and increased velocities. The construction of the Missouri River Levee System along with roadway and railroad embankments have contributed to increased flood stages (5+ feet), well in excess of 1 foot allowed by modern standards. These increased stages lead to increased frequency of overtopping of levee systems, as well as to higher hydrostatic forces, increased seepage, and ultimately higher risk of failure prior to overtopping. In addition to vulnerabilities to Missouri River levees revealed by damages from the 2011 flood event, various other vulnerabilities have been identified that have the potential to impact multiple levees or the entire Missouri River levee system.

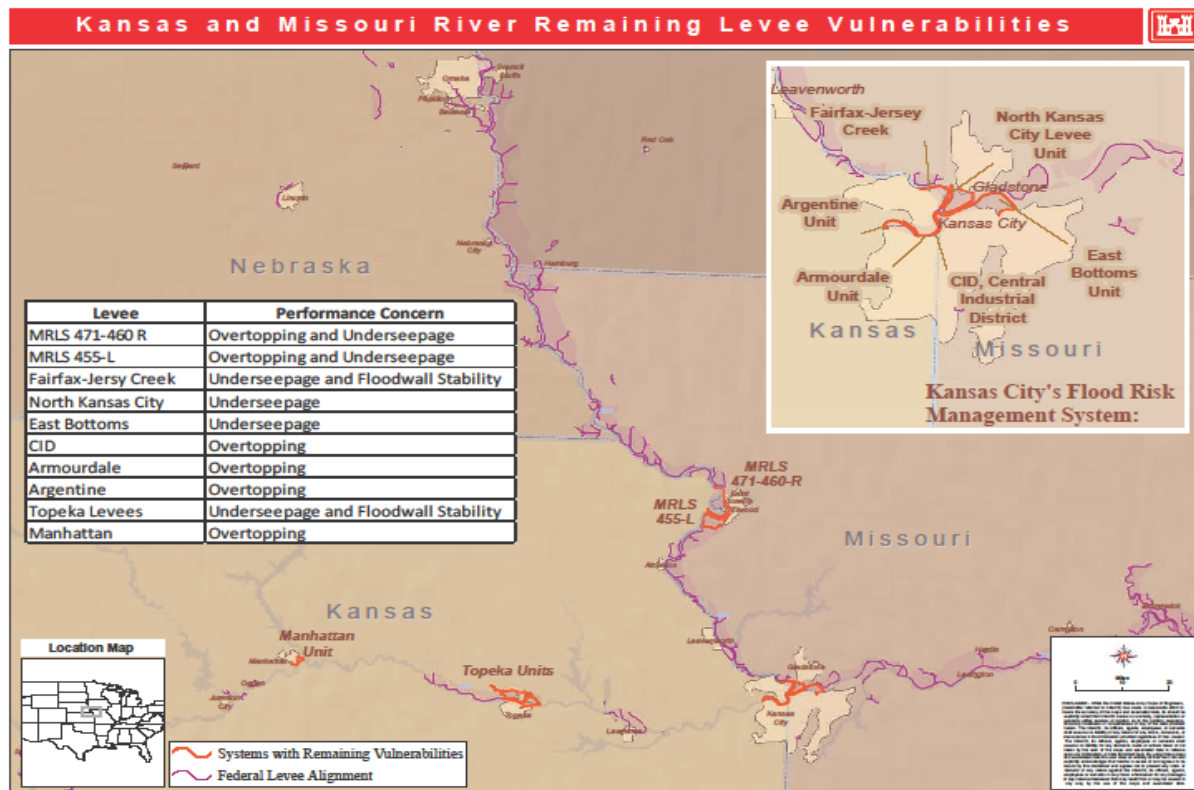
The federal levee system of the lower basin has shown vulnerabilities to flood events since the 1993 flood event. Flood events within the lower basins, including the 2011 event, has exposed vulnerabilities within federal levee system for over 20 years. Vulnerabilities of federal levees providing flood risk management along the major metropolitan areas of the Missouri mainstem and its Kansas River tributary have the potential to impact over \$22 billion in economic infrastructure, as well as, the working environment and residences of nearly 200 thousand individuals within the metropolitan areas. Four major levee systems within the lower basin of the Missouri River and tributary continue to show vulnerability to major flood events; MRLS 455 and R460- 471, Kansas City's Levee system, Topeka Levee system, and Manhattan levees. These federal levees do not meet authorized design levels due to infrastructure weakness and/or low levee heights resulting in potential for undermining the integrity of the levee system through underseepage, flood walls failure, and overtopping of levees during high water events. These levee systems continue to fail to meet their authorized design levels and remain problematic vulnerabilities within the basin flood protection system. Of the four levee systems, two levee systems have units in the feasibility study phase (Kansas City Levees and Manhattan Levees) with the other two levees in design or have recently initiated construction contracts. These metropolitan areas and their high value regional and national economic structure remain high priority vulnerabilities due to underfunding for completion of study, design and construction. Restoration of the authorized levels of protection should remain a high priority to stakeholders of the basin.

**Figure 58. Kansas and Missouri River Remaining Levee Vulnerabilities**

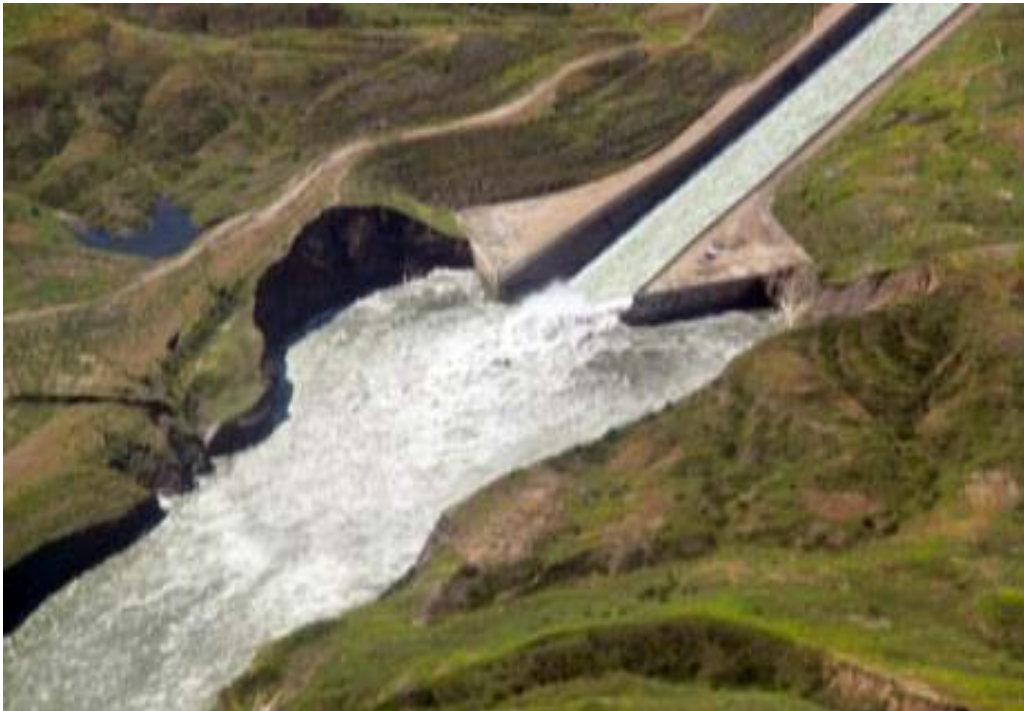
**Figure 65. Dams damage/erosion: Fort Peck - Erosion along the spillway plunge pool extending from Fort Peck's spillway in Fort Peck, Montana**

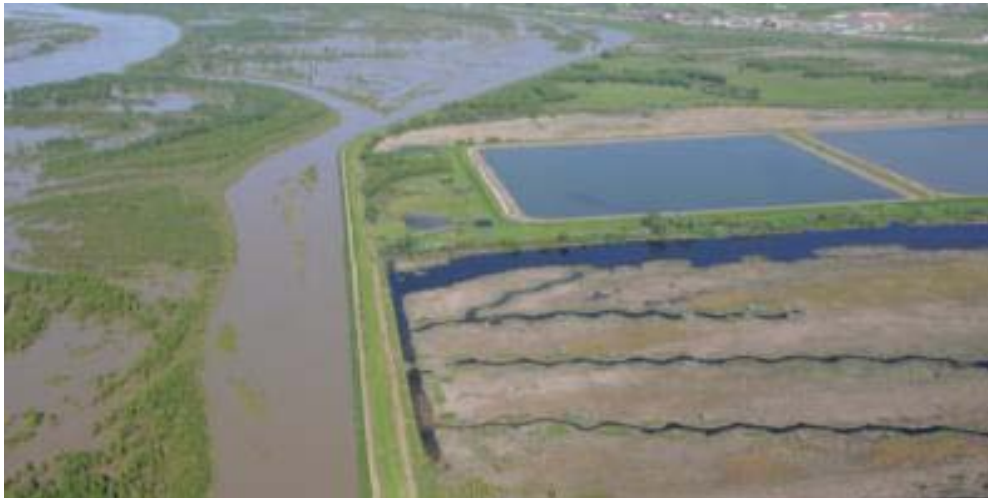
**Figure 66. Levee seepage: Williston - Landside seepage, relief wells needed at Williston Levee, North Dakota**

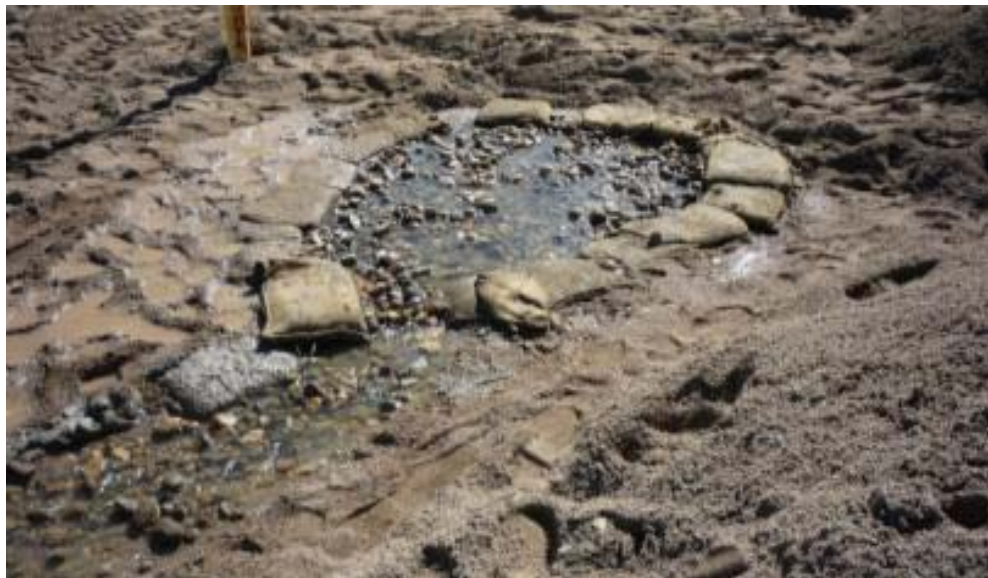
**Figure 67. Levee boils: Williston - Additional relief wells needed at Williston Levee in North Dakota**

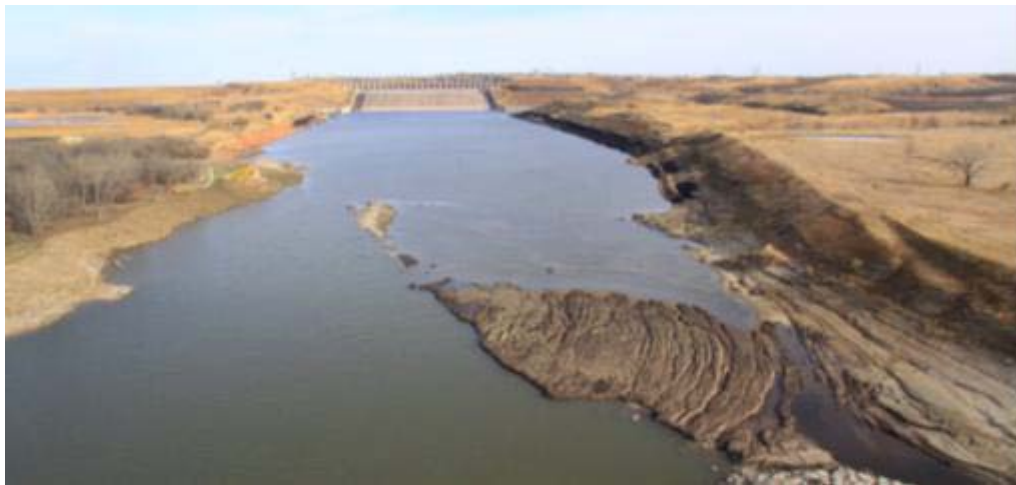
**Figure 70. Dams damage/erosion: Garrison - Erosion along the earthen walls extending from Garrison Dam's spillway apron in North Dakota**

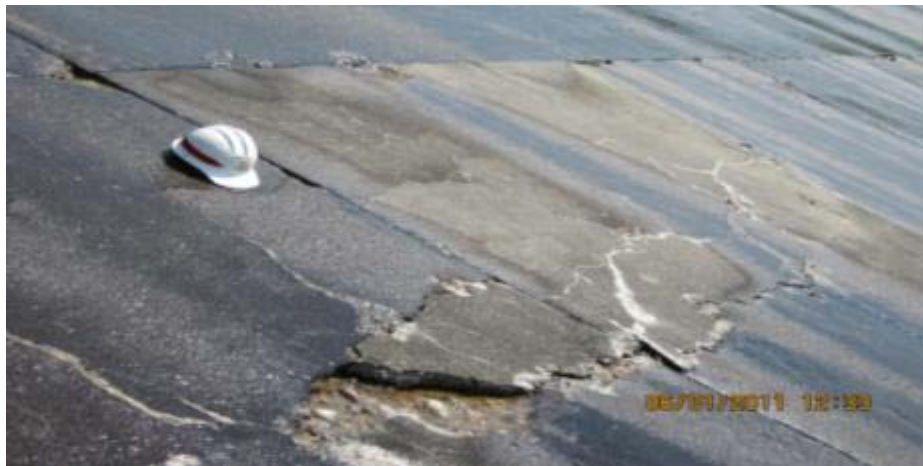
**Figure 71. Garrison Spillway damage/erosion:**

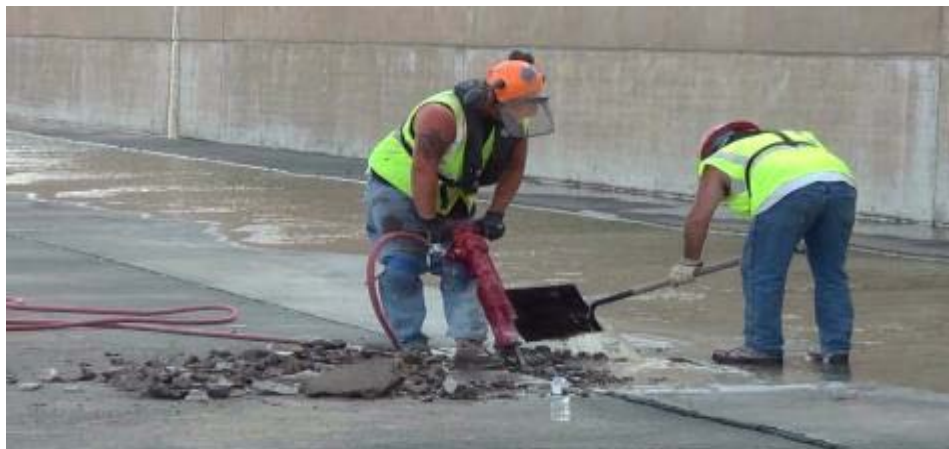
**Figure 72. Dams damage/erosion: Garrison - Typical concrete repair from flood in North Dakota. Additional spall repairs needed at most dams.**

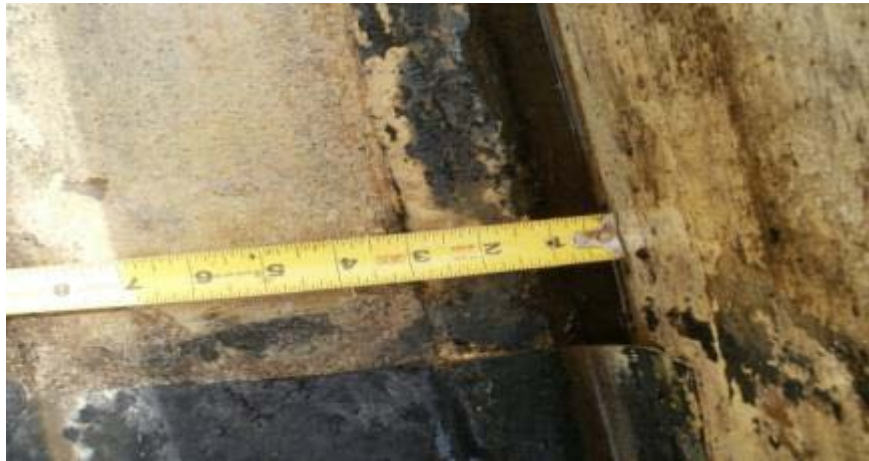
**Figure 73. Dams damage/erosion: Garrison - Joint separation and seal repairs required at Garrison Dam in North Dakota**

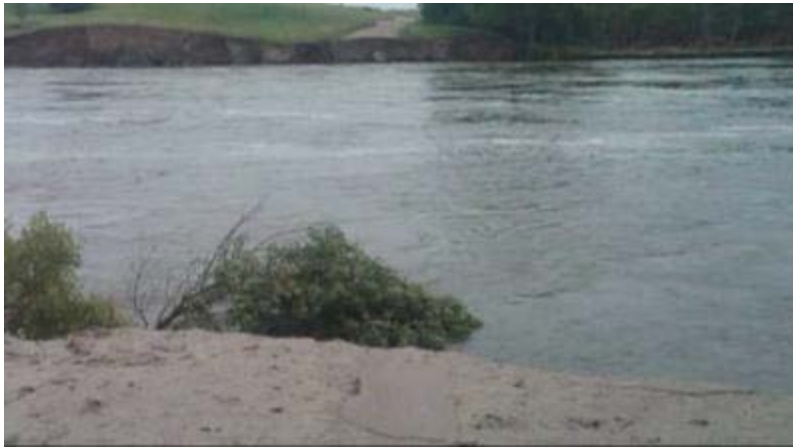
**Figure 74. Dams damage/erosion: Garrison - Erosion along the earthen walls extending from Garrison Dam's spillway apron in North Dakota**

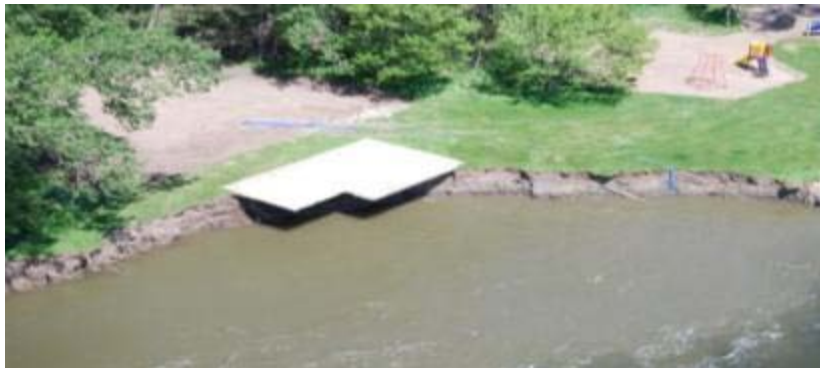
**Figure 75. Dams damage/erosion: Garrison - Downstream camp erosion at Garrison Dam in North Dakota**

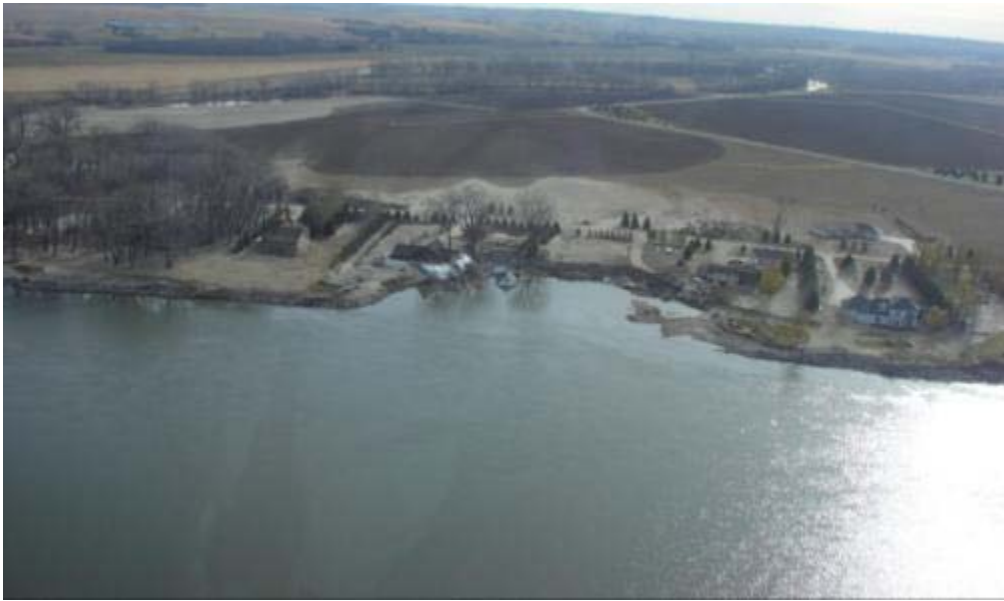
**Figure 76. Erosion: Hogue Island, Section 33 Project - Erosion along the Section 33 Project at Hogue Island, North Dakota**

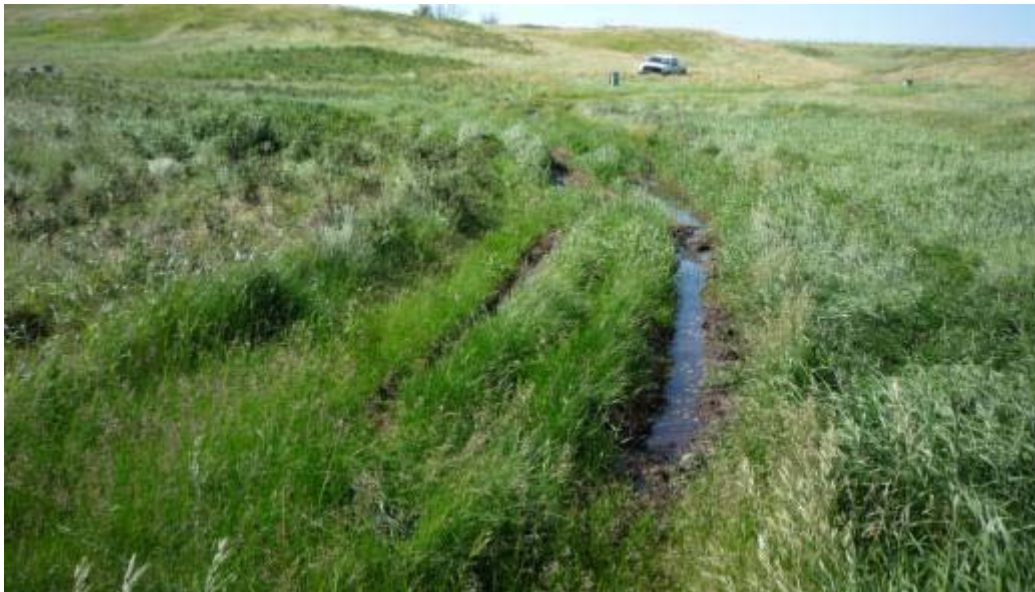
**Figure 77. Dams damage/erosion: Pipestem Dam - Downstream right abutment seepage area at Pipestem Dam in South Dakota**
